## CASE STUDY

**Restoration of availability through repair and overhaul of crankcase and cylinder**

Compressor manufacturer: BORSIG			
Type	BX28-20/2S2	Gas	NG
Power	700 kW (952 hp)	Suction pressure	1.8 bar (26 psi)
Speed	375 rpm	Discharge pressure	8.8 bar (128 psi)
Lubrication	yes

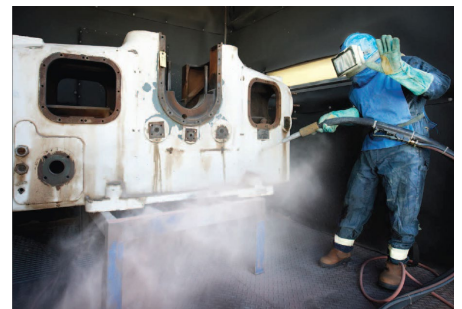
*Cleaning the crankcase*

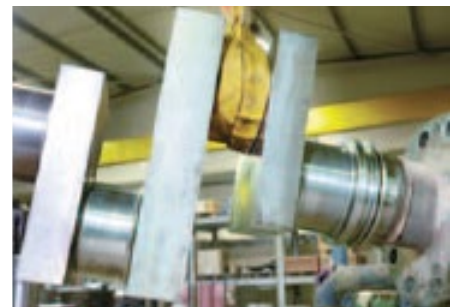
*Crankshaft removed from the crankcase for inspection*

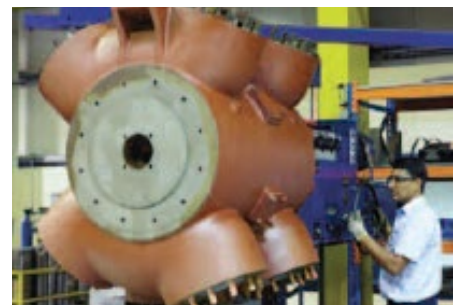
*Cylinder repaired*

- Upgrade the pressure packing to HOERBIGER BCD rings
- Upgrade the oil wiper packing to OT oil wiper rings
- Install new cylinder rings
- Repair the cylinder and cylinder cover
- Replace the second-stage cylinder liner with one of improved surface quality
- Supervise installation and commissioning
