## CASE STUDY

A French chemical plant had to replace a crosshead guide due to an age-related crack (the compressor is 40 years old).

**Improved reliability and efficiency under changed conditions due to compressor upgrade**

### Compressor manufacturer: ATLAS COPCO CREPELLE

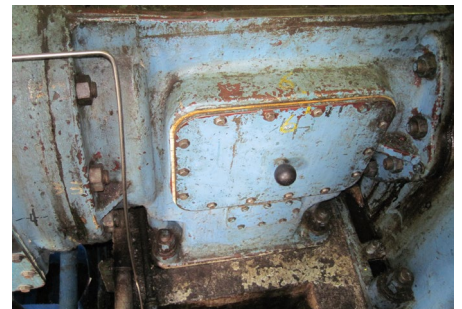
*Old, cracked crosshead guide*

- Crosshead guide cracked after 40 years of operation
- No spares available from compressor manufacturer

- Inspected the cracked crosshead guide, with on-site meeting to clarify any doubtful points
- Used original AC Crepelle drawings from customer to cast and machine new crosshead guide
- Final checks (magnetic particle and ultrasonic inspection)
- Supervised installation
- Re-machined crosshead
- Old crosshead guide was repaired by Atlas Copco, with increased diameter
- Project management and documentation

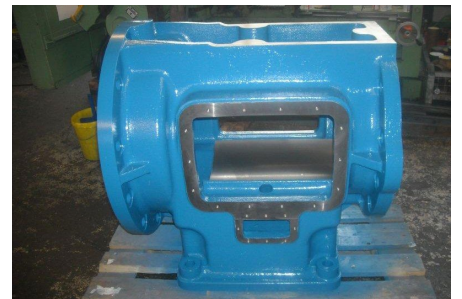
*Finished crosshead guide*

- New crosshead guide was manufactured to dimensions and quality approved by the customer
- Crosshead guide was delivered and installed as requested

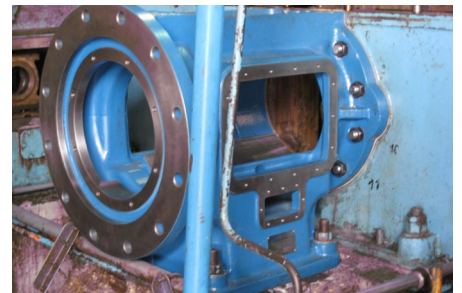
*Crosshead guide installed on the compressor*
