CASE STUDY

A German refinery was facing corrosion problems on the recycle compressors of its hydrodesulphurisation unit.

Reliability optimization through adaptation of the compressor to the corrosive gas

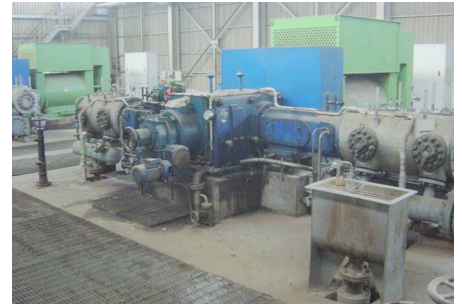
Compressor with old cylinder design

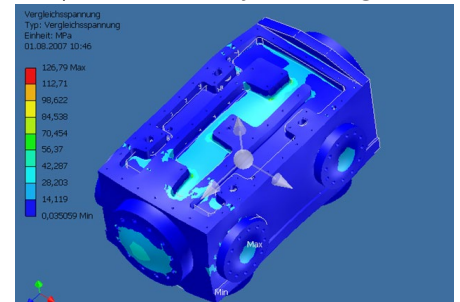
3D design and finite element calculation

- Measurement of the original cylinder on site
- Material selection (CK35) to avoid corrosion problems
- Finite element stress calculation for new cylinders
- Construction and production of the cylinders, and design of the cylinder liners
- Pressure and leakage tests
- Assembly and installation of all new parts on site
- Project management and documentation

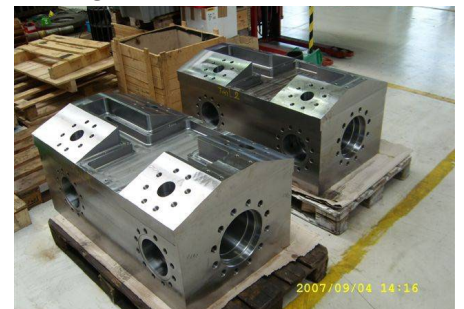
Production of new forged cylinder

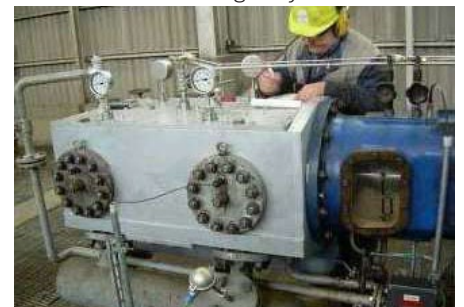
One of four new cylinders installed and tested

- The rebuilt compressors have been running since 2008 with no corrosion problems
- The liners effectively protect the cylinders from wear by the piston rings
