CASE STUDY

A refinery in Germany needed help from HOERBIGER to overhaul an existing H₂ compressor and its foundation.

Increased availability and reliability through full overhaul and service also extended the lifetime of the compressor

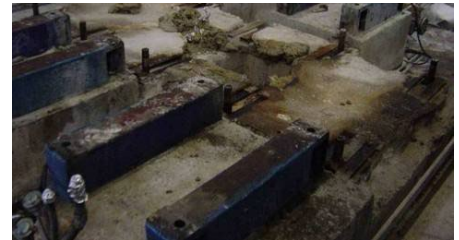
Compressor totally dismantled from the foundation

- Disassembly of the complete units including piping, vessels and internals for a complete rebuild, including laser alignment
- New epoxy grouting
- Bore shafts installed to allow on-site machining of the bearing tunnel in both frames
- Installation of repaired crankshaft, crossheads and new bearings
- Project management and documentation

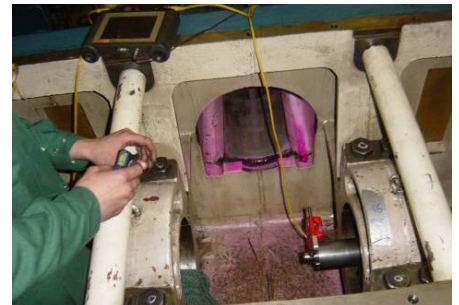
Laser alignment and boring of bearing tunnel

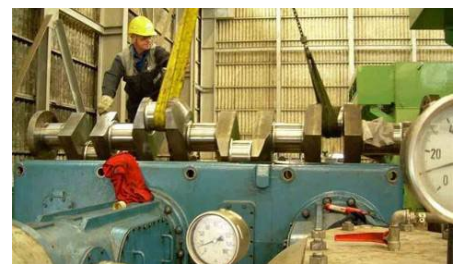
Crankshaft assembled

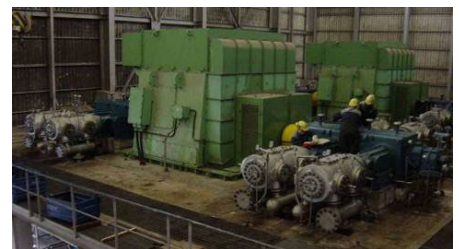
Overhauled compressor with low bearing temperatures

- The compressor is now more durable
- The bearings run at lower temperatures due to the reduced web deflection of both crankshafts
