CASE STUDY

Restored availability by repair of a badly damaged crankcase

Compressor manufacturer: MB HALBERSTADT

Type	4HB12K-400/290	Gas	H ₂ mix
Power	5100 kW (6934 hp)	Suction pressure	12 bar (174 psi)
Speed	375 rpm	Discharge pressure	37 bar (537 psi)
Lubrication	yes

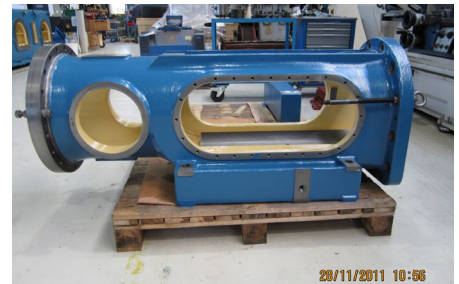
Crosshead guide

- Inspected damaged crankcase
- Took 6th row out of service and clamped crankcase to stop crack growth
- Approved for limited operation (balanced operation mode)
- Cast and machined new crankcase following original MBH drawings, to which HOERBIGER has the rights
- Sourced all necessary auxiliary equipment
- Specified installation procedure
- Project management and documentation

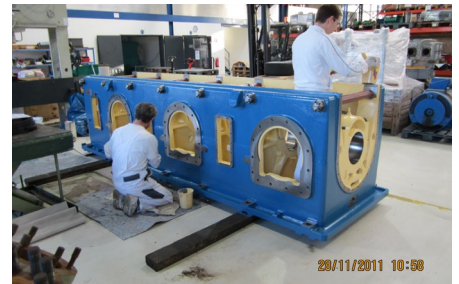
Finished crankcase

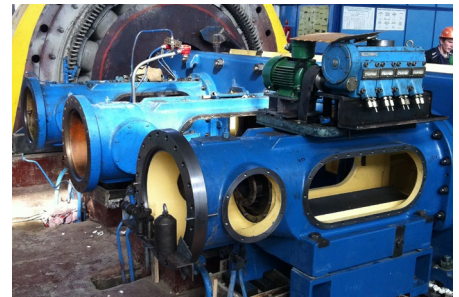
Assembly of crankcase and crosshead guide

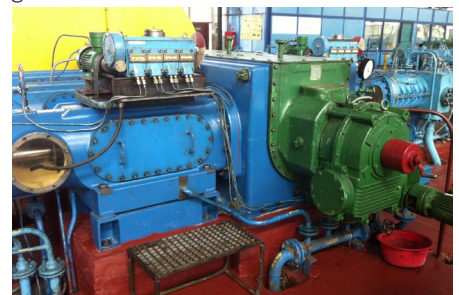
New crankcase and cross head guide in operation

- Trouble free operation after repair
- Crankcase, crosshead guide and all auxiliary equipment delivered in time
- All goods inspected and approved for dimensions and quality
- All delivered parts installed and compressor is in operation again
