## Bolivia – Remanufactured Engine

Engine model: Waukesha 12V-AT27GL			
<b>Power</b>	3,140 Horsepower	<b>Length</b>	14' (4.26 Meters)
<b>Speed</b>	750 – 1000 RPM	<b>Width</b>	6' (1.82 Meters)
<b>Height</b>	10.6" (3.23 Meters)	<b>Weight</b>	52,000 lbs. (23,665 kg)

### Facts in Brief

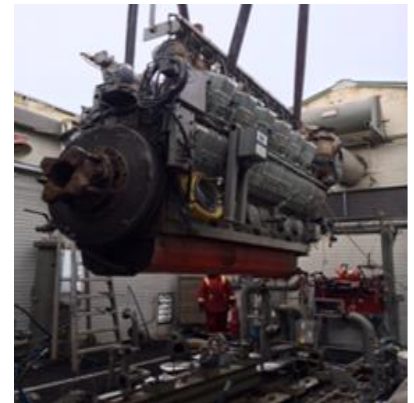
Core Engine Removal

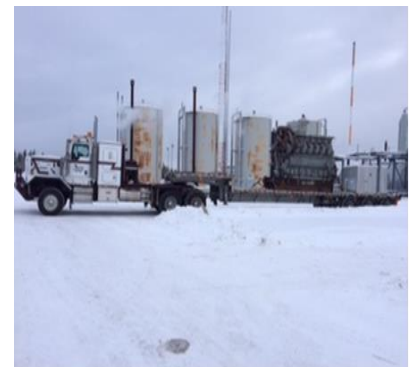
Core Engine Transportation

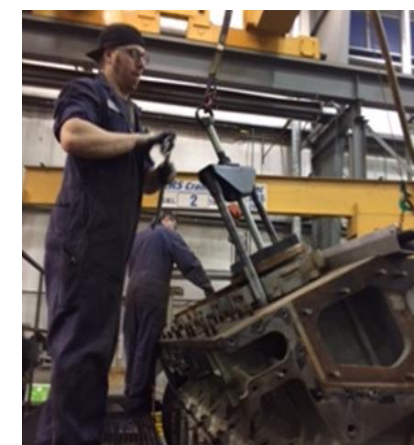
Tear Down Process begins...

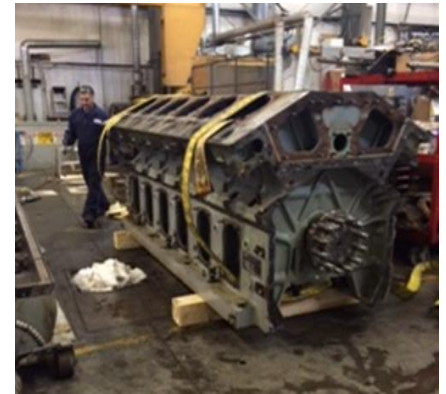
*Tear Down Process*

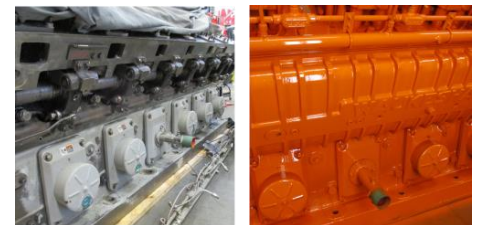
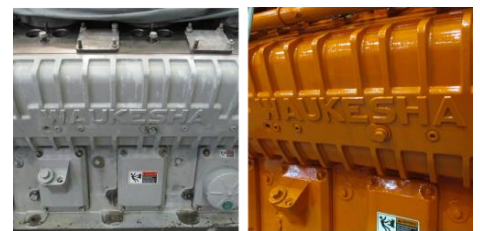
*Before Process – Work in Progress*
