## CASE STUDY

A French chemical plant had to replace a crosshead guide due to an age-related crack (the compressor is 40 years old).

**Improved reliability and efficiency under changed conditions due to compressor upgrade**

### Compressor manufacturer: ATLAS COPCO CREPELLE

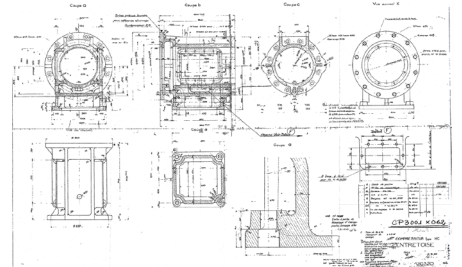
*Original drawing for crosshead guide*

- Inspected the cracked crosshead guide, with on-site meeting to clarify any doubtful points
- Used original AC Crepelle drawings from customer to cast and machine new crosshead guide
- Final checks (magnetic particle and ultrasonic inspection)
- Supervised installation
- Re-machined crosshead
- Old crosshead guide was repaired by Atlas Copco, with increased diameter
- Project management and documentation
